GTI ENERGY PROJECT NUMBER 21513

**Pilot Test of a Nanoporous, Super-hydrophobic Membrane Contactor Process for Post-combustion CO<sub>2</sub> Capture**

DOE Contract No. DE-FE0012829

October 6, 2022

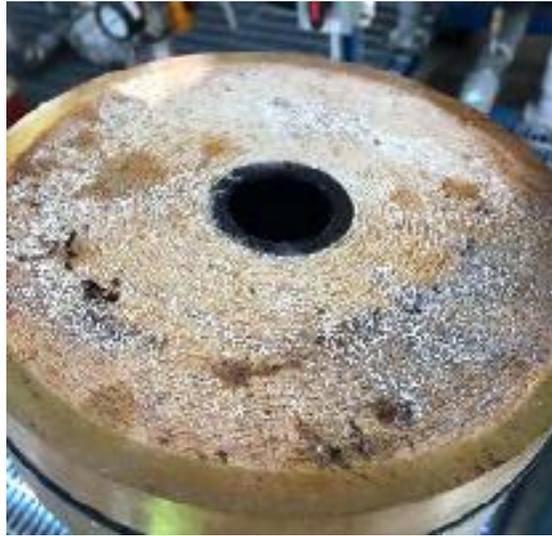
The post-test inspection found some white, powdery material and rust particles on the flue gas inlet side of the membrane (Figure 25). Analysis indicated the white material is calcium sulfate (possibly from the FGD system) or sodium sulfate (possibly from NCCC's pre-scrubber system). Further quantitative analysis indicated three potential causes of the decline in performance: 1) contaminants (powder and rust particles); 2) vapor condensation in fiber bores; and 3) capillary condensation of vapor in

**Figure 25.** Photograph of the flue gas inlet side of the membrane after testing.

PEEK pores. After discussing with DOE, the decision was made to resolve the issue of contaminants (powder and rust particles) first.

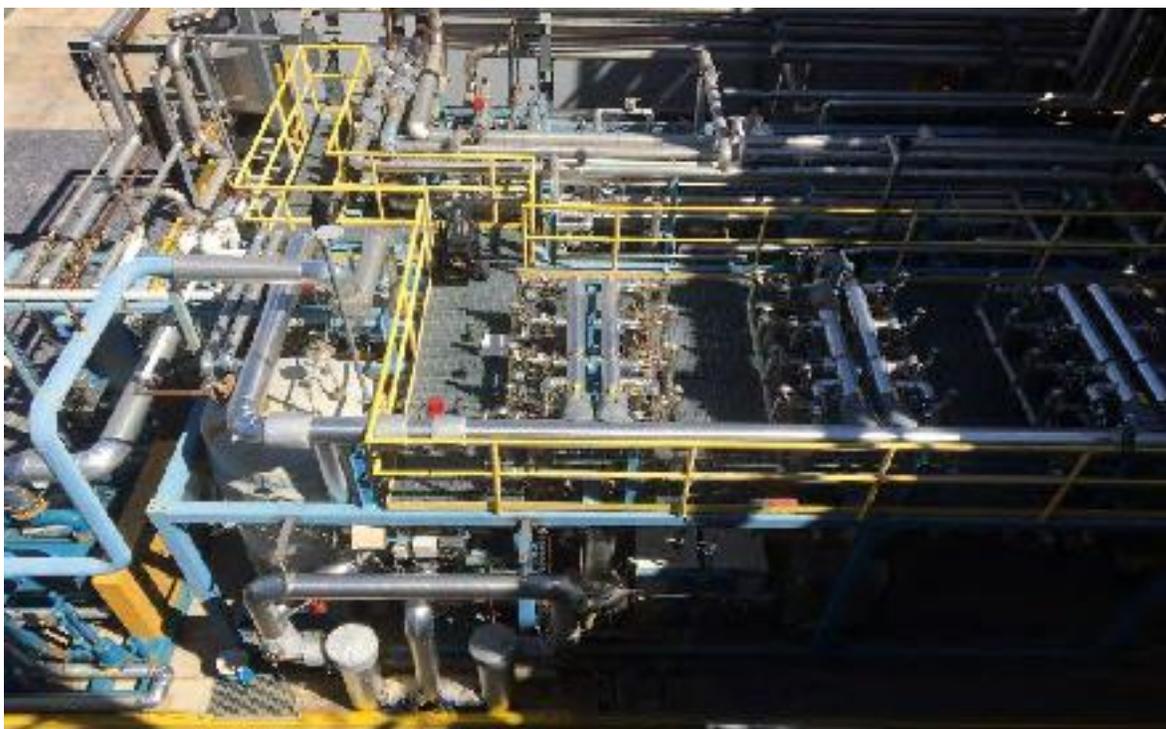
**Figure 27.** Modified skid piping.

As planned, piping modifications to the pilot system were completed (Figure 27). Each new orifice plate assembly had an orifice plate with pressure taps and a dedicated differential pressure gauge. The liquid orifice plates were installed on the liquid outlet (rich solvent) with a 0-20 psid differential pressure gauge while the gas inlet orifice plates were installed with a 0-10 psid differential pressure gauge. The flows calculated from these new liquid and gas orifice plates, coupled with the rich amine thermocouples previously installed on each membrane, allowed the performance for each membrane to be determined. New stainless-steel filter housings (Figure 28) were also installed.

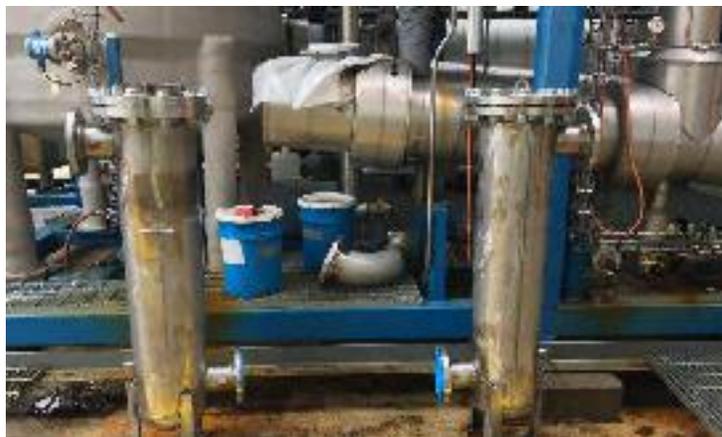
**Figure 28.** Stainless steel filter housing.

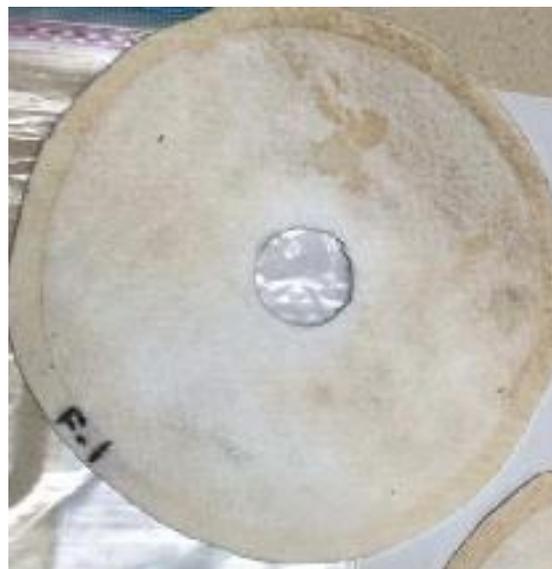
**Figure 35.** A used mesh pad from the top surface of a membrane after 2021's testing.

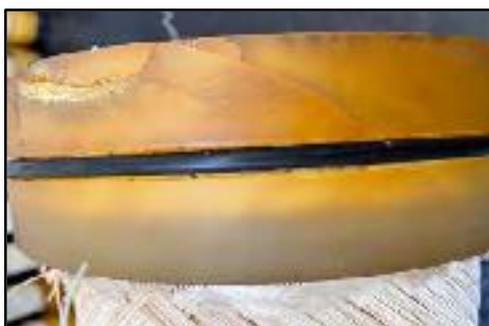
Four membrane cartridges (P190139, P190144, P190165, and P190166) were returned to the Air Liquide Advanced Separations (ALaS) facility in Woburn MA (ALaS – Woburn) from the NCCC test site for analyses to identify the potential causes for the CO<sub>2</sub> absorption performance degradation during the field operation. Initial inspection of P190166 revealed a severe crack in the neat epoxy section of the tubesheet (Figure 38). The crack traversed the O-ring groove, rendering the O-ring ineffectiveness in sealing the cartridge in the shell. Cartridge P190166 was replaced with P190167 for the analysis, including bundle level requalification using the standard manufacturing quality control (QC) test protocol. The crack occurred during removal from the membrane housing.

**Figure 38.** Cracked tubesheet of cartridge P190166.

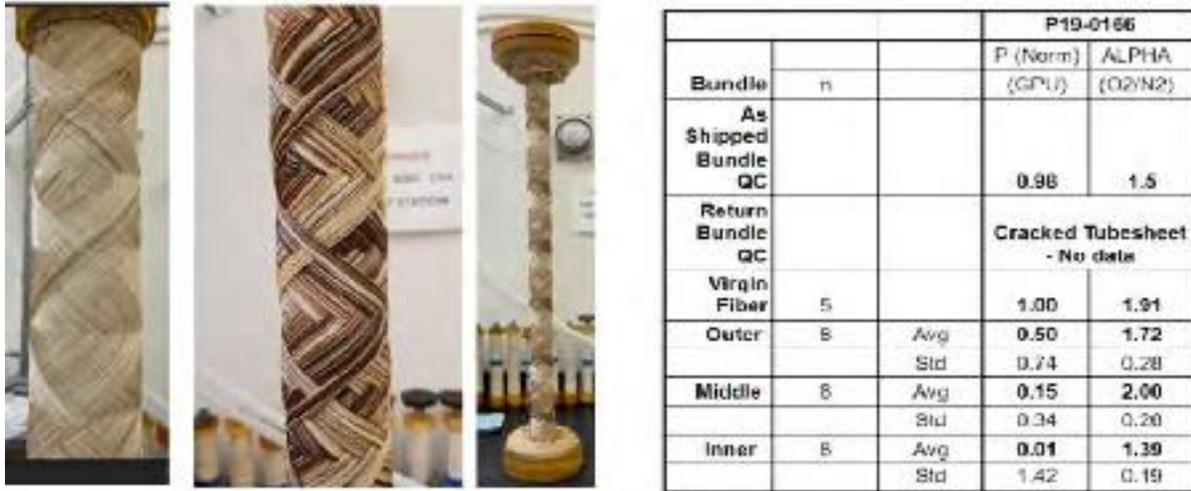
Cartridge P190166 was the first bundle to be autopsied. This cartridge could not be tested upon receipt due to the large tubesheet crack across the O-ring groove. Figure 39 shows layers of fiber from the OD of the fiber mass to the ID of the fiber mass as the autopsy progressed. The results are unusual, unexpected, and difficult to explain. The

OD of the bundle, just inside the elastic sock (employed to protect the fiber from handling during module production), appears reasonably normal. The majority of the fibers are light, with minimal if any discoloration. There are 4 brown fibers present running the length of the cartridge. Moving to the midpoint of the fiber mass, a heavily discolored area of the fiber is revealed. There are fibers of normal color intertwined with intense brown-colored fiber. At the fiber mass ID, there is a mix of fiber colors, but none with the color intensity of the fiber mass midpoint. Fiber samples collected from each region as described above were tested for O<sub>2</sub>/N<sub>2</sub> permeance and selectivity.

**Figure 39.** Autopsy pictures of Bundle P190166 (cracked tubesheet).

P190166 (cracked tubesheet) showed a far greater impact from contamination than all other cartridges. It also showed the largest degree of contamination. This is either consistent with this cartridge having the highest leak rate, or it suggests the operation of the cartridge with the crack present. Either of these issues would lead to gross contamination by the amine solution.

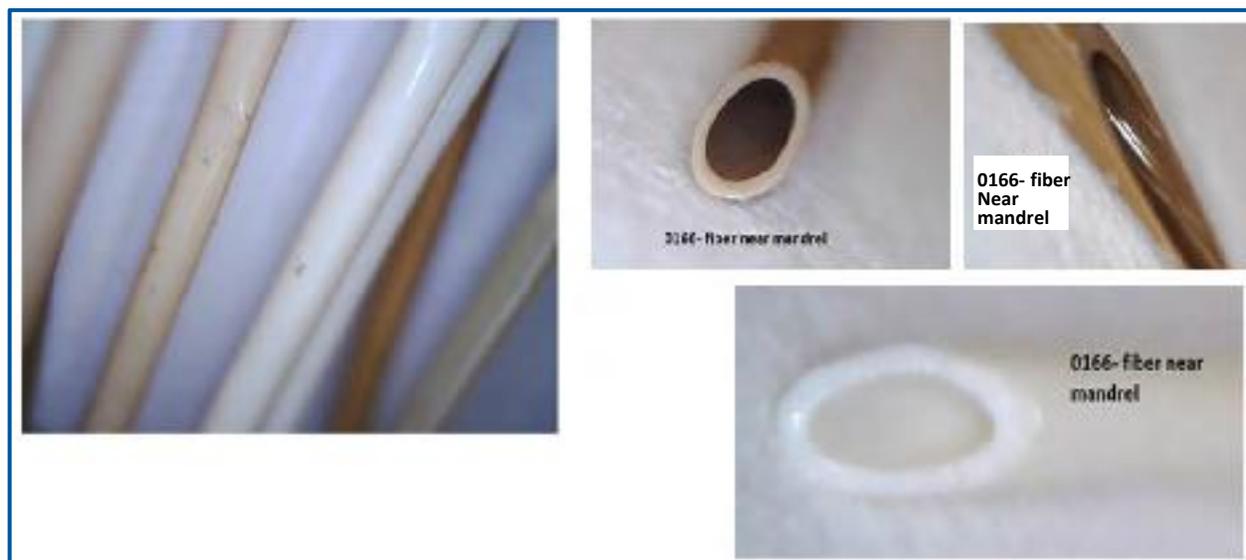
The difference between the brown and white fiber is striking (see Figure 40). FTIR and ATR-FTIR were performed on the discolored fiber. It was determined that isopropyl alcohol (IPA) could extract color from the **chopped** fiber. Immersion of unchopped brown fiber with the ends of the fiber outside of the IPA bath extracted no color. It was deduced that the origin of the color was extracted from the fiber bore.

**Figure 40.** Close-up photographs of discolored fiber.

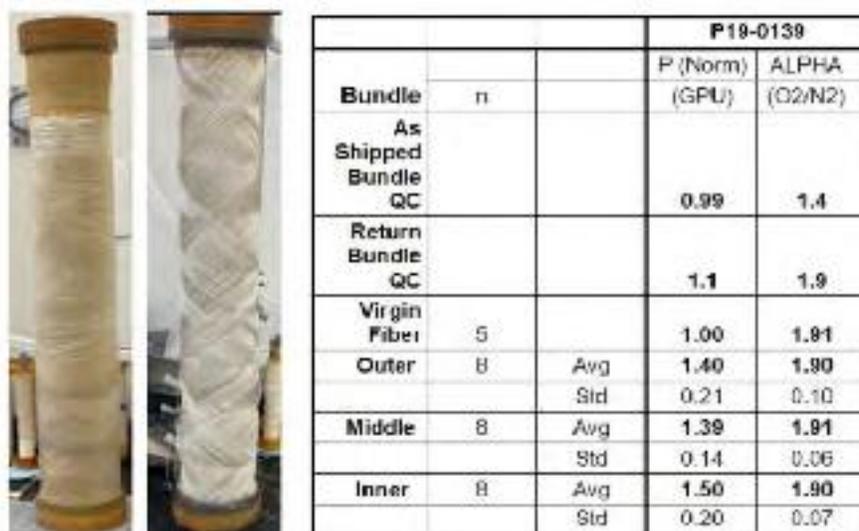
Cartridge P190139 contained minimal brown fibers and like all other cartridges, no blue-stained fiber. The bundle-level QC performance indicated an increase in permeance and selectivity. Individual testing on the three layers of fiber yielded similar performance. Permeators made from the three layers had permeance higher than that of virgin fiber and selectivity very similar to that of the virgin fiber (Figure 43).

**Figure 43.** Cartridge P190139 - autopsy pictures and fiber performance.

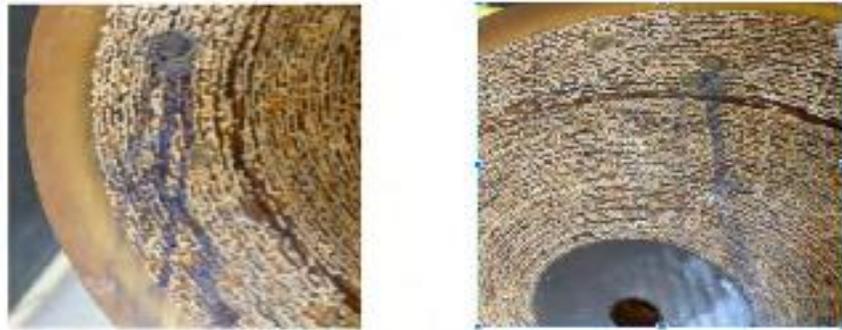
The tubesheet face of P190139 showed two major leaks. Both were associated with patching of leak points from manufacturing as evidenced by the circular plugs (Figure 44). This is unexpected and unusual.

**Figure 44.** Dye stains originating from tubesheet patches.

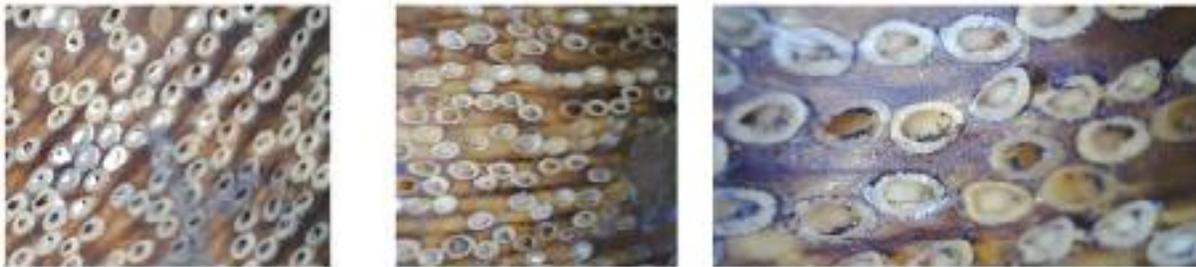
Further inspection of the tubesheet wafer shows evidence of white debris in the bore of the fiber as well as tinges of rust color (Figure 45). The rust color could also be the result of amine contamination due to the tubesheet leak. The white powder in the fiber bore indicates that Cause 1A (Table 4) is not fully addressed.

**Figure 45.** Photographic evidence of debris in the fiber bore in P190139.

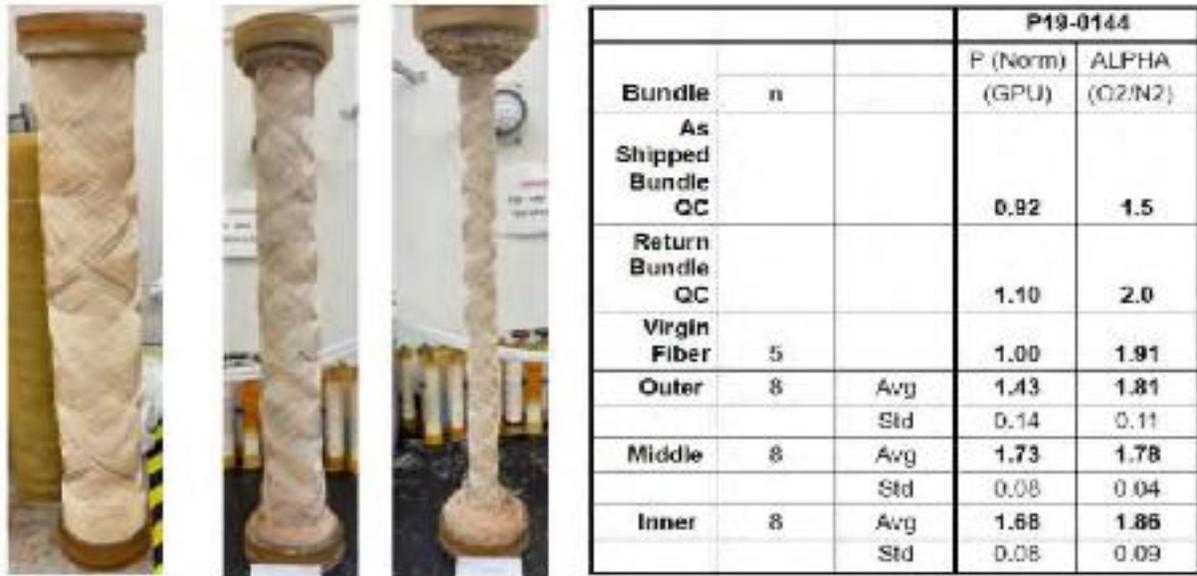
Autopsy and analysis of cartridge P190144 yielded results very similar to P190139 (Figure 46). There are very few brown discolored fibers. Again, entire fiber lengths are either white or discolored. Bundle-level QC results of the returned cartridge are higher than the as-shipped QC results. Fiber level performance indicates high O<sub>2</sub> permeance and O<sub>2</sub>/N<sub>2</sub> selectivity slightly lower than virgin fiber. The lower value could be interpreted as a defect in the coating, but the O<sub>2</sub>/N<sub>2</sub> selectivity is higher than the as-shipped bundle and no fibers were dyed blue.

**Figure 46.** Cartridge P190144 - autopsy pictures and fiber performance.

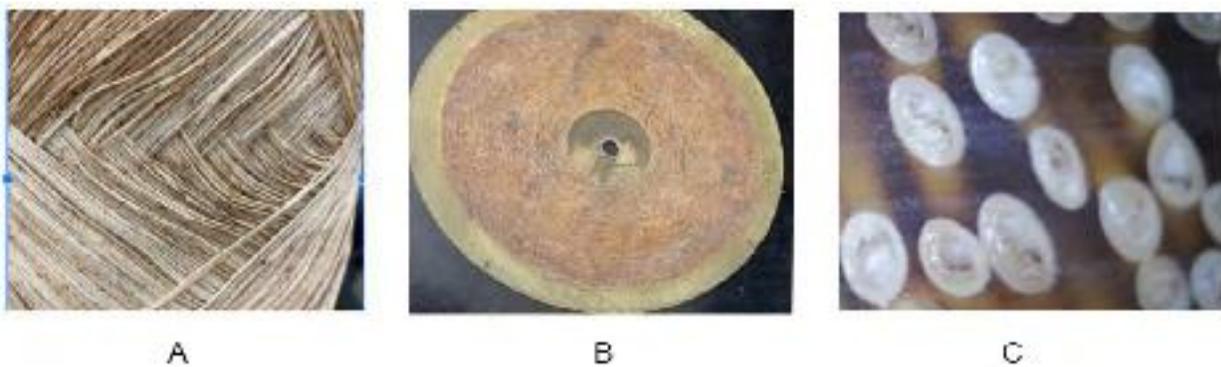
**Figure 47.** Tubesheet leak and debris on cartridge P190144.

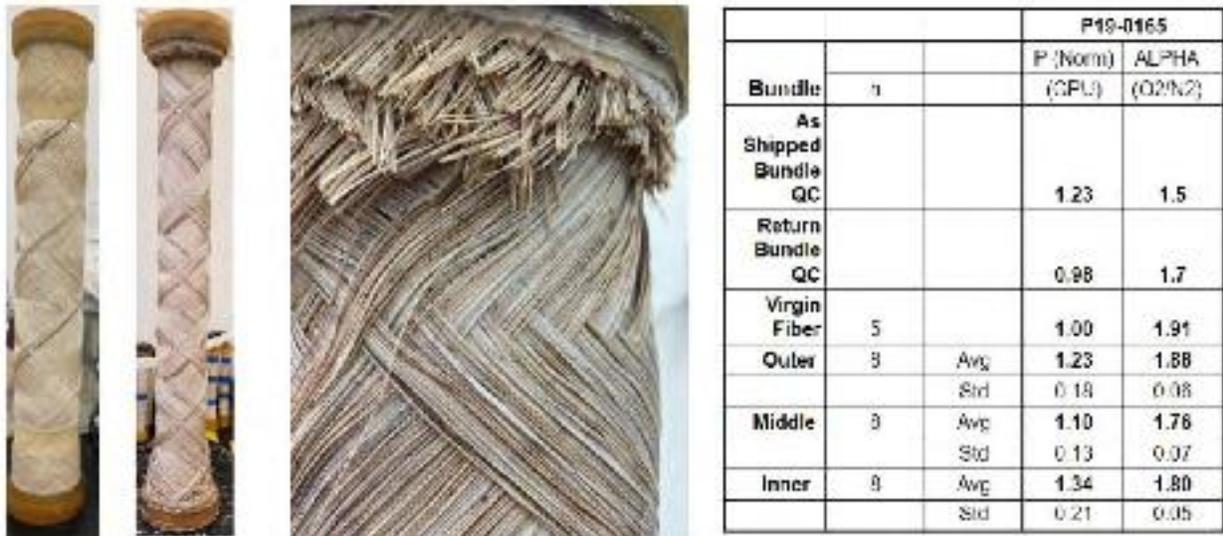
**Figure 48.** Cartridge P190165- autopsy pictures and fiber performance.

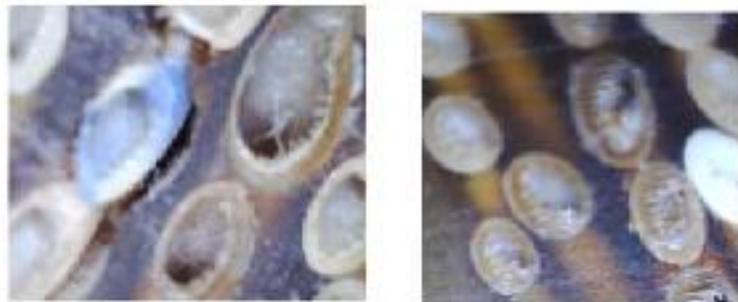
**Figure 49.** Cartridge P190165 tubesheet - white debris in fiber bore, delamination, and crystal violet dye.

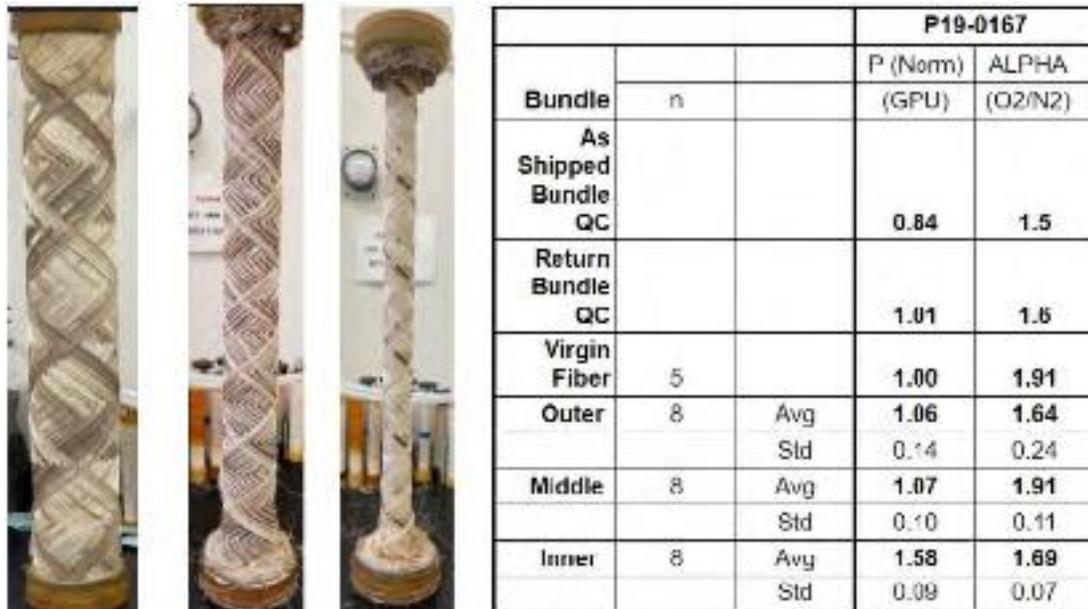
**Figure 50.** Cartridge P190167- autopsy pictures and fiber performance.

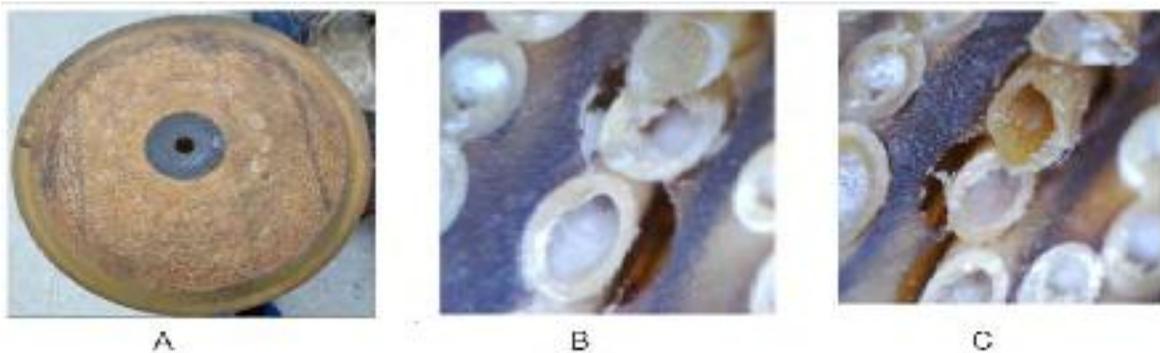
**Figure 51.** Cartridge P190167- autopsy pictures and fiber performance.

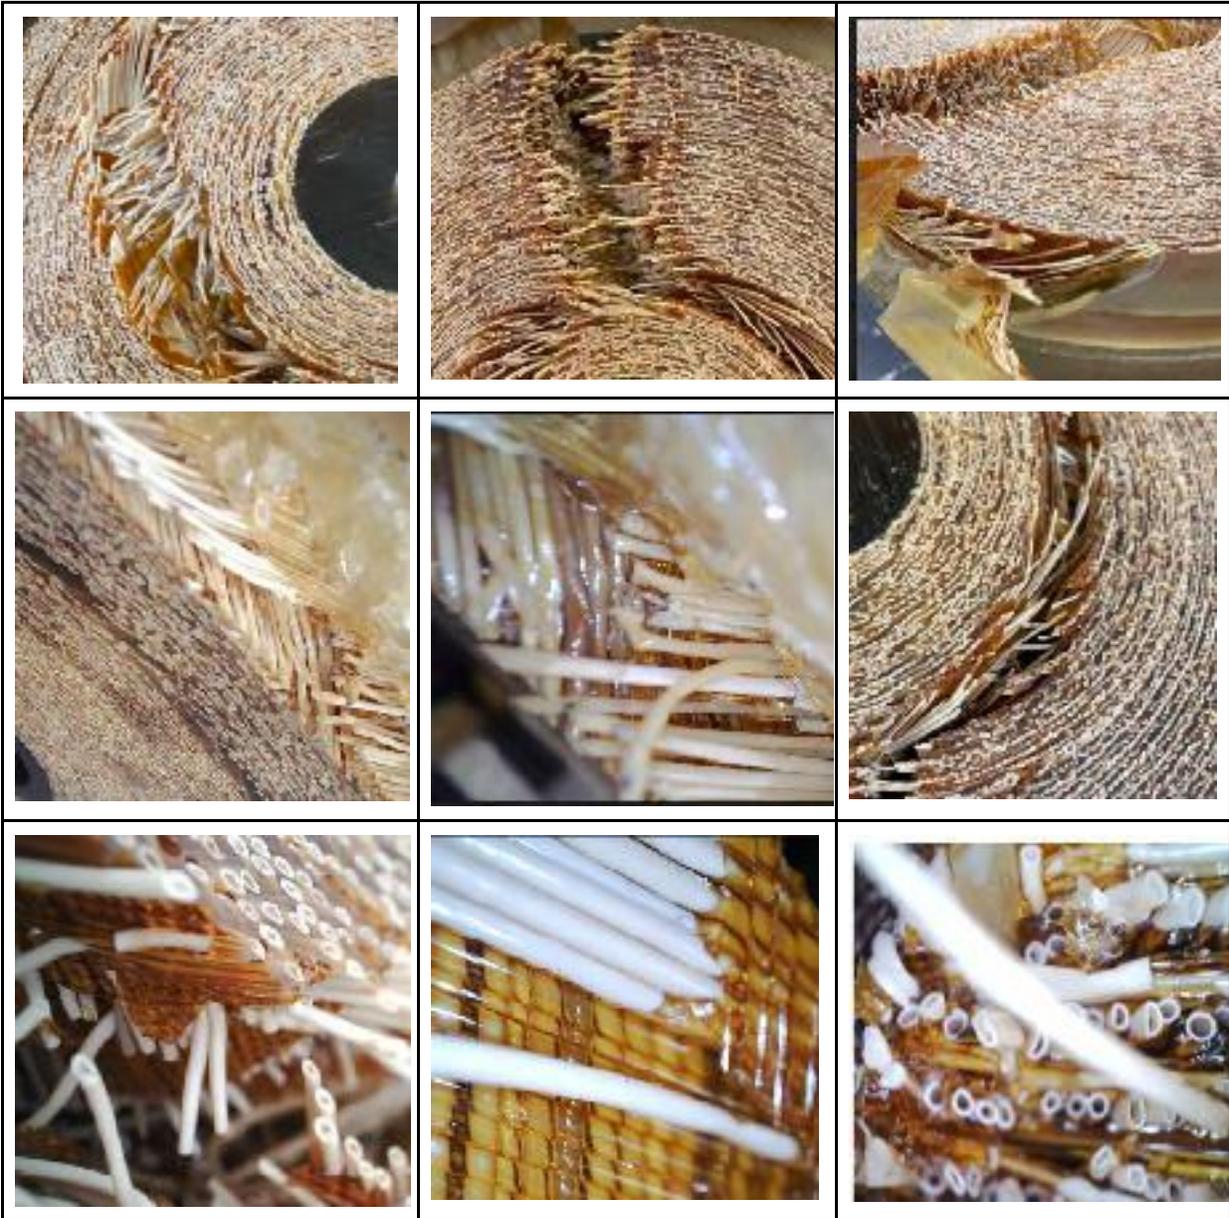
**Figure 52.** Fractured tubesheet samples showing delamination of fiber from epoxy.
