GTI ENERGY PROJECT NUMBER 21513

**Pilot Test of a Nanoporous, Super-hydrophobic Membrane Contactor Process for Post-combustion CO<sub>2</sub> Capture**

DOE Contract No. DE-FE0012829

October 6, 2022

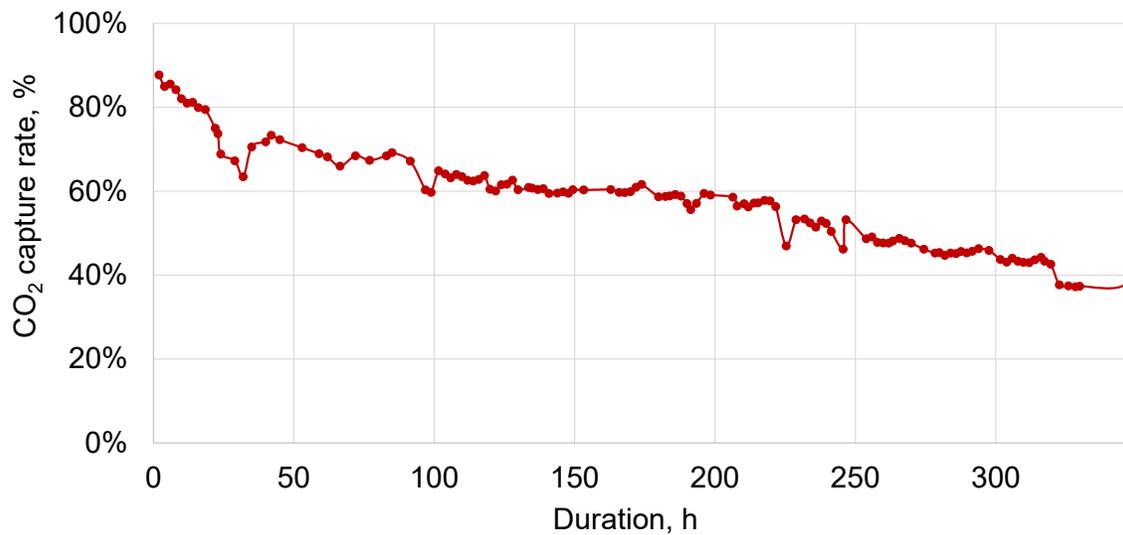
**Figure 34.** 2021's membrane contactor CO<sub>2</sub> capture testing results with 28 fresh modules.

Due to the impacts of COVID-19 and the unavailability of coal flue gas at NCCC, further testing could not be conducted until early 2021. Once testing resumed, a decline in performance was observed for the first 347 hours during 2021's testing with 28 modules (Figure 34). Inspection suggested that the inlet mesh pads were clean after system improvements, with no visible rust or particulates present on the mesh pads (Figure 35), indicating the issue of particles accumulation on the membranes had been resolved.

Two approaches were attempted to recover the membrane performance: 1) a water wash followed by air dry; and 2) an air dry without a water wash. For the first approach (water wash followed by air dry), the following steps were included:

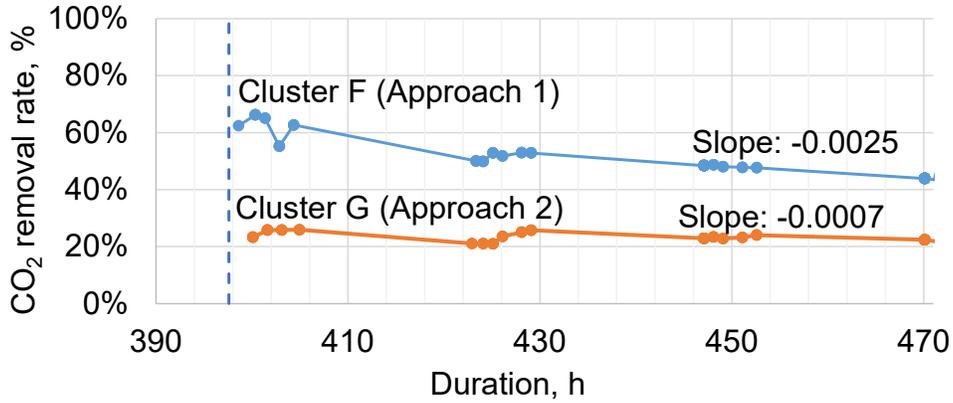
**Figure 37.** Performances of Cluster F and G modules after different approaches were employed.

Approaches 1 and 2 were employed for Cluster F and G modules respectively. As shown in Figure 37, air purge alone was not sufficient in recovering performance. In contrast, a water wash followed by an air purge can recover the performance but didn't resolve the continual decline issue. The effects of operating conditions (data not shown here) such as feed flue gas temperature and DP between liquid and gas sides were also investigated. The change in these conditions did not improve stability.

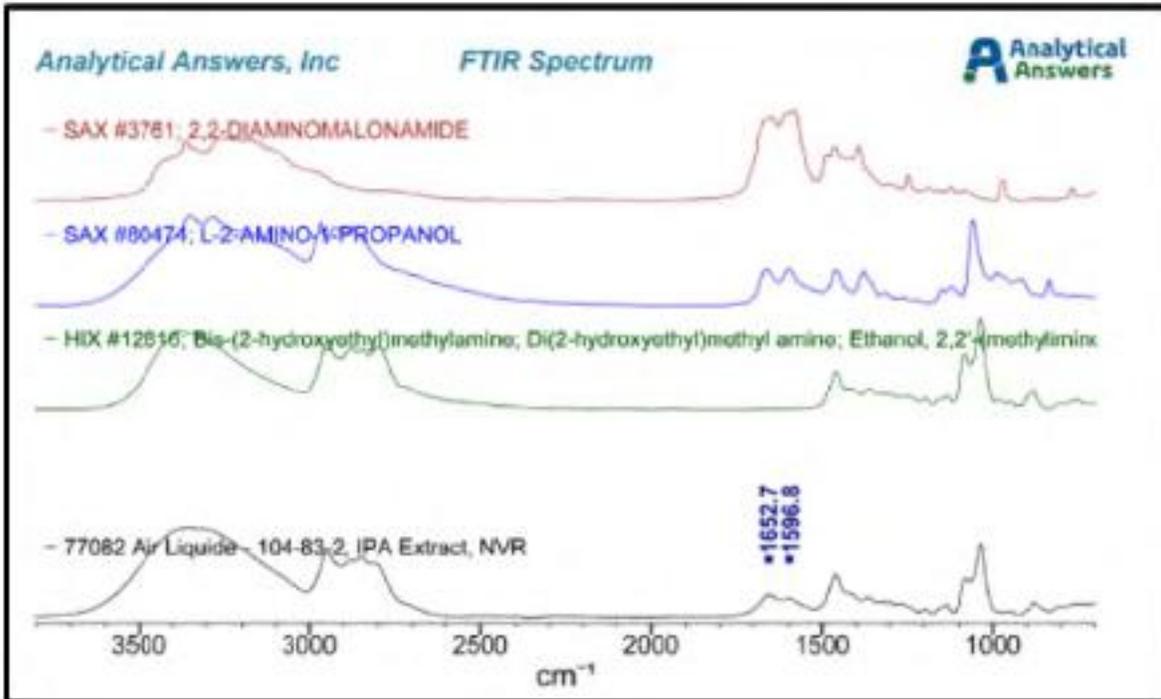
**Figure 41.** FTIR analysis of IPA extractant from chopped brown fiber.

As shown in Figure 41, FTIR of the IPA extract is compared to the reference spectrum for MDEA and two representative amine /amide compounds (2,2-Diaminomalonamide, L-2-Amino-1-Propanol, Bis-(2-hydroxyethyl)methylamine, and Di(2-hydroxyethyl)methyl amine). The FTIR traces are very similar. The presence of the extra ~1650 and ~1590 bands indicates that additional carboxylate ions may be present which suggests MDEA degradation products.

Contact transfer ATR-FTIR from the fiber OD surface detected silicone oil and low levels of degraded MDEA. No information was obtained from the fiber ID due to the inability to make crystal contact with the fiber.

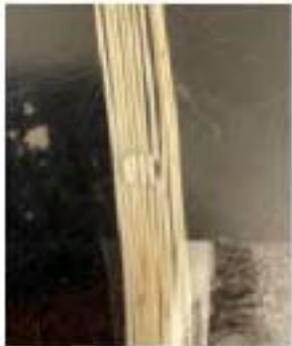
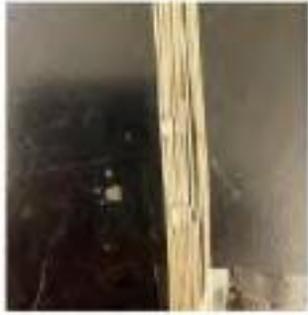
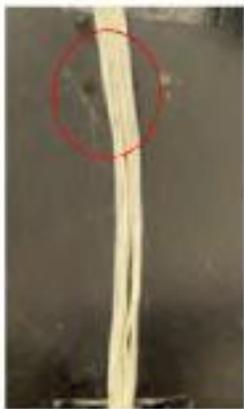
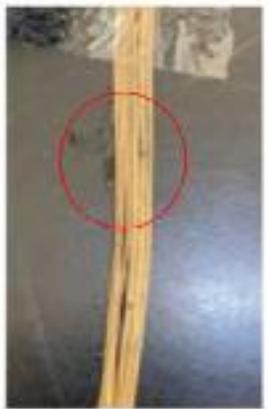
**Figure 42.** Surface tension estimates of virgin, white, and discolored fiber.

The red circles in Figure 42 highlight the liquid addition. Beads were observed with the addition of water (72.8 dyne/cm) and ethylene glycol (47.7 dyne/cm). Neither of the liquids wetted any of the fibers. There was no evidence of bead formation with Dichloroethane (33.3 dyne/cm) addition. Dichloroethane wetted all fibers. This work was repeated with 10 samples yielding the same result.

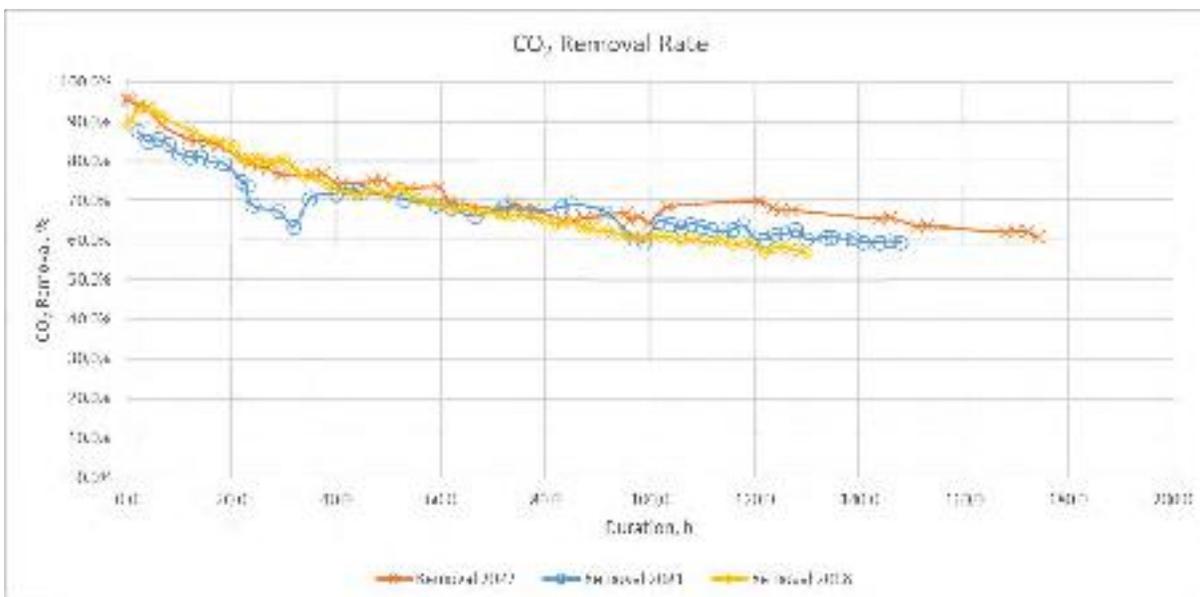
**Figure 54.** CO<sub>2</sub> removal rate as a function of operating time for tests conducted in 2018, 2021, and 2022.

GTI Energy personnel installed the four membranes into the pilot test unit (Cluster A) and recommissioned the unit. The recommissioning of the unit proceeded without issue. The membranes were then tested for CO<sub>2</sub> capture in gas-liquid contactor mode. The initial testing points showed good CO<sub>2</sub> capture performance. However, over the next 100 hours, the CO<sub>2</sub> removal and CO<sub>2</sub> removal flux continued to decline. Figure 54 shows that the rate of performance decline is similar to the full-scale tests conducted in 2018 and 2021.

During the test, an amber-colored solution was collected from the gas outlet low point drain. Further measurements indicated the collected solution contained about 20-21 wt.% amine, compared to the 34-35 wt.% amine in the bulk solvent. This indicates some solvent was entering the bore side. At the end of testing, the four membrane modules were washed, dried, and shipped back to ALaS for inspection.
