## Field Test of Rosemount<sup>™</sup> 5078 3D Solids Scanner, A Novel Coal Silo Measurement Device, at the National Carbon Capture Center

December 12, 2017

U.S. Department of Energy Cooperative Agreement DE-FE0022596

Southern Company Services, Inc.

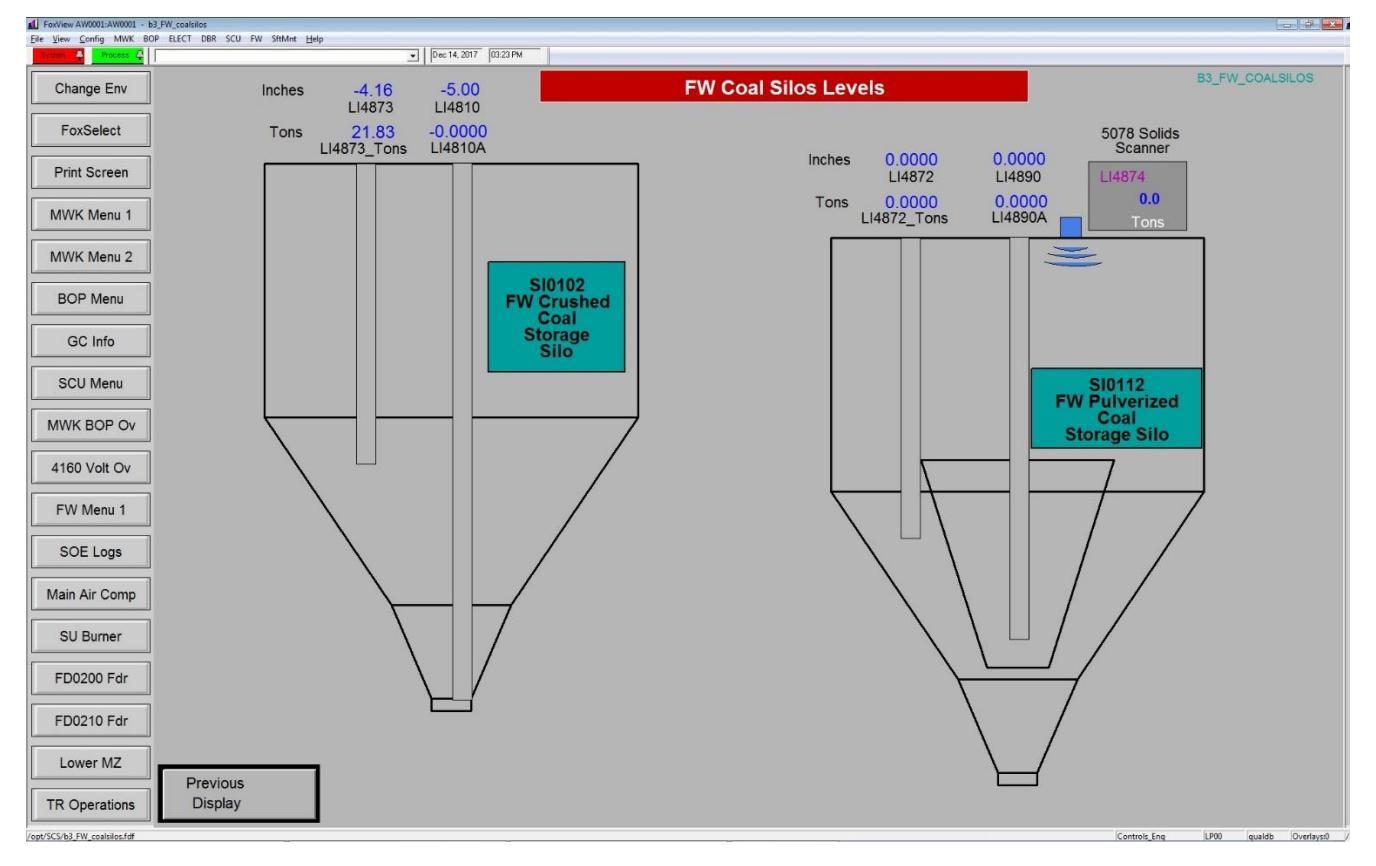
Figure 1 – Location of Level Measurement Devices in the Coal Silos

During the G-5 gasification test-run from March to April of 2017, the National Carbon Capture Center (NCCC) tested a unique level measurement device, the Rosemount 5078 3D Solids Scanner. It was installed on a pulverized-coal silo equipped with existing guided wave radar and capacitance probe level measurements. This location provided a direct comparison of each technology's accuracy and benefits. NCCC staff worked closely with Rosemount's application engineers to best site a mounting location for optimal performance. The capacitance probe (LI4890) is located in the center of the vessel, and the guided wave radar (LI4872) is located near the edge of the vessel. The Rosemount 5078 3D Solids Scanner (LI4874) is located just off center on top of the vessel on an existing flange (See Figures 1 and 2).

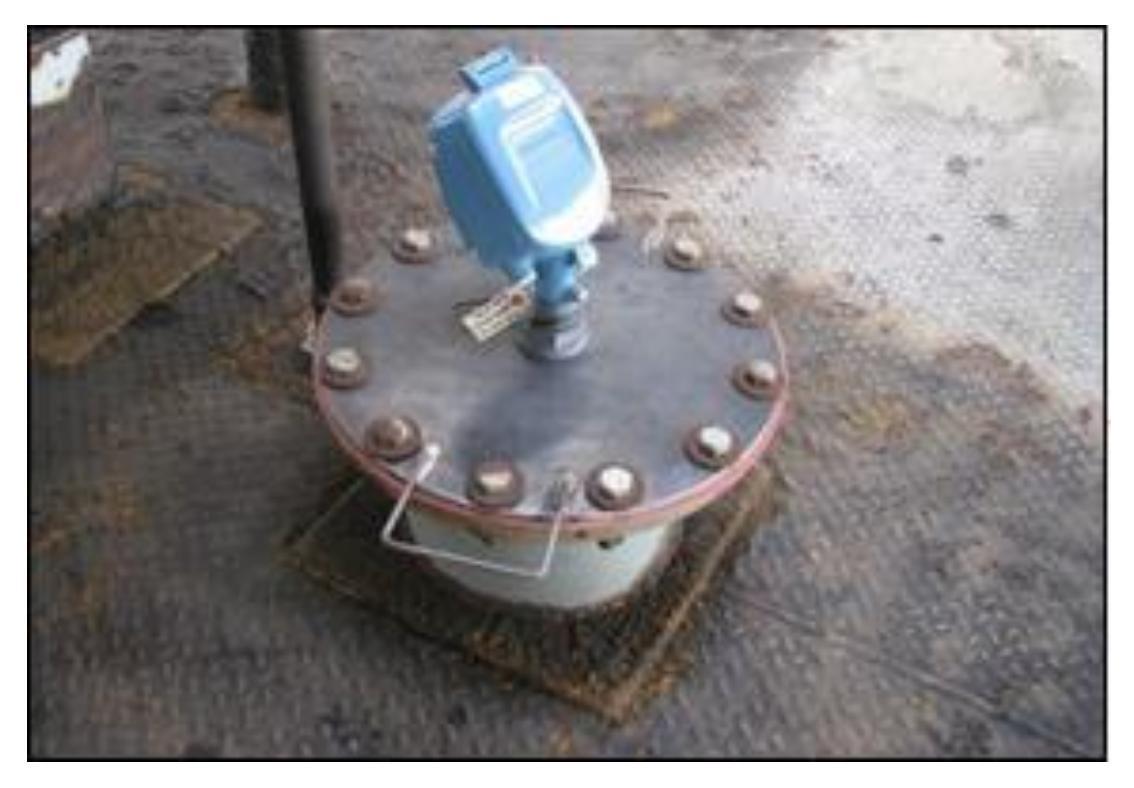
Figure2 – Rosemount 5078 Solids Scanner Actual Installation

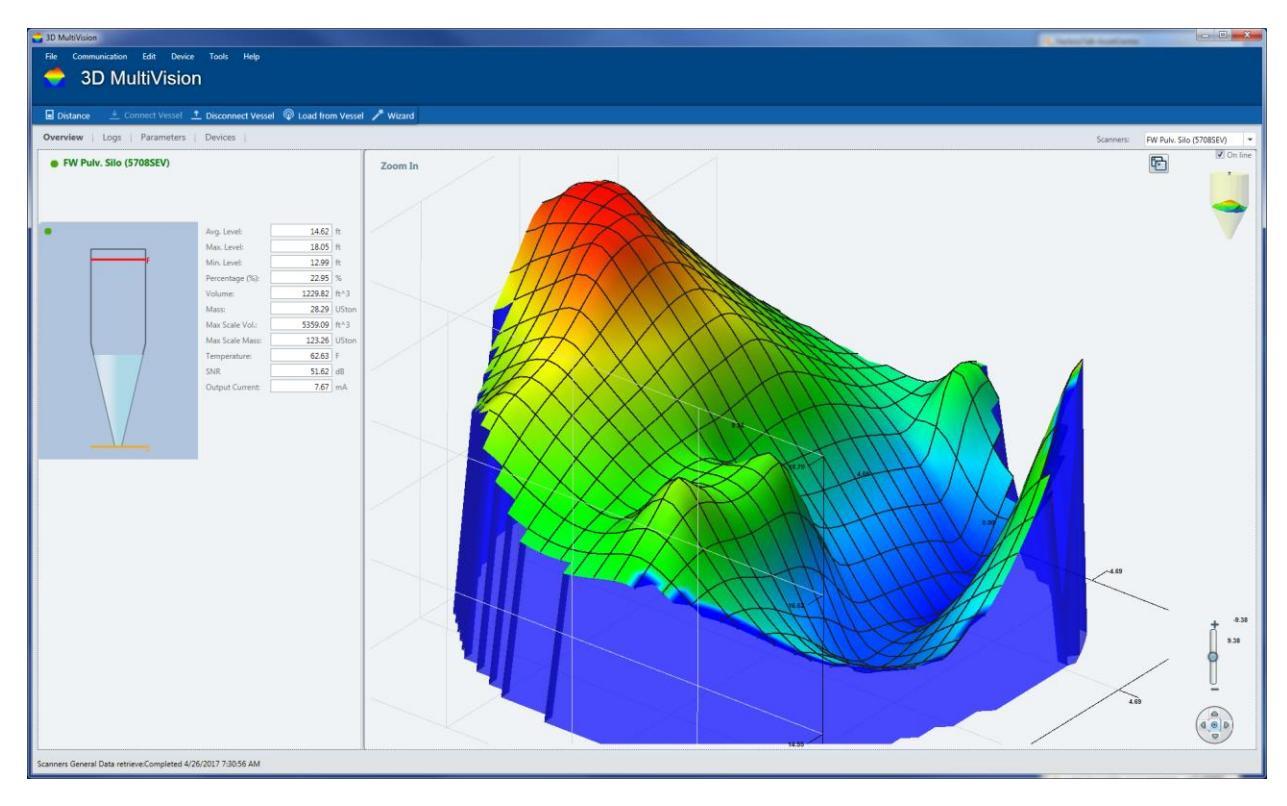
Figure 3 - 3DMultiVision<sup>™</sup> View of Pulverized-Coal Silo Showing Uneven Level

Unlike traditional technologies, the Rosemount 5708 uses acoustic, phased-array technology that generates a dust-penetrating, low-frequency acoustic wave, and then receives echoes from the contents. The collection of the echoes allows the Rosemount 5708 to calculate level and volume of the vessel. The 3D visualization constructed in the Rosemount 3DVision/Rosemount 3DMultiVision<sup>™</sup> software is based on multiple points collected by the Rosemount 5708 and represents the material surface identified by the devices. It also provides information on material formations within the vessels (see Figures 3, 4, and 5).

The Rosemount 5708's 3D visuals were also valuable for analysis and troubleshooting. Being able to visually see the level and possible issues of uneven distribution and "rat-holes" allowed the NCCC team to make corrections sooner to prevent disruptions in operation. Other advantages of the Solids Scanner are that it requires little maintenance and has no moving parts to malfunction. The instrument does not require re-calibration, and its self-cleaning design prevents material from accumulating on the antennas, ensuring reliable performance in dusty conditions.

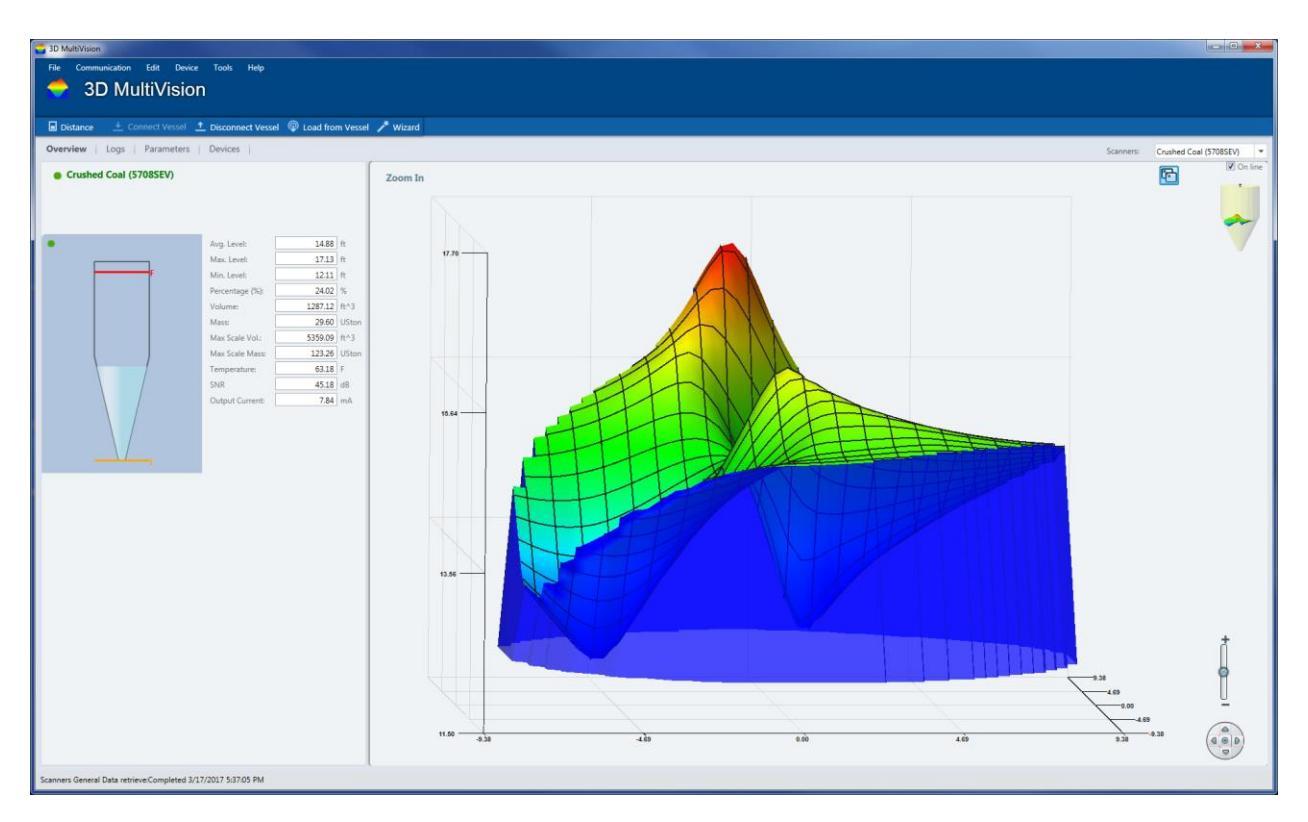
Figure 4 - 3DMultiVision<sup>™</sup> View of Pulverized-Coal Silo Showing Possible "Rat-holing"

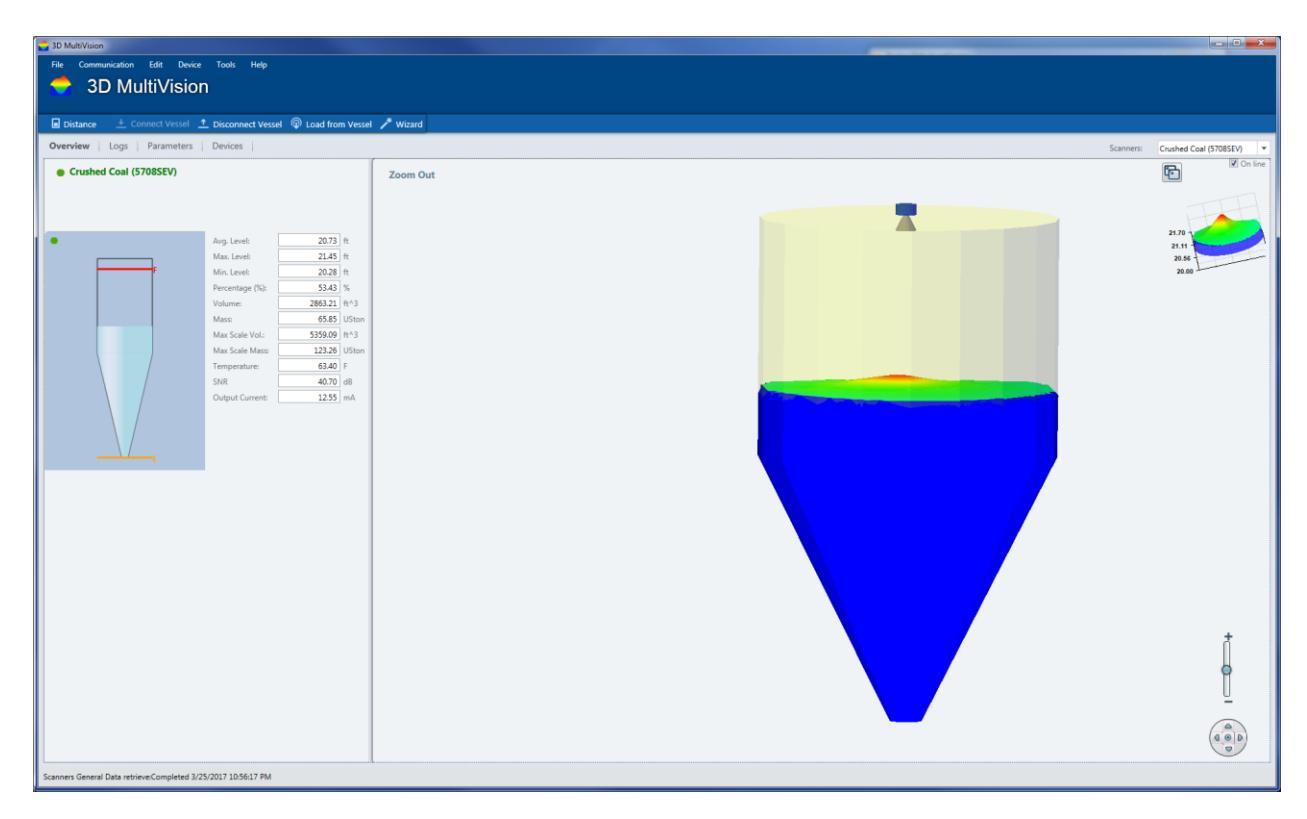
Figure 5 - 3DMultiVision<sup>™</sup> View of Pulverized-Coal Silo Showing a Level Coal Distribution

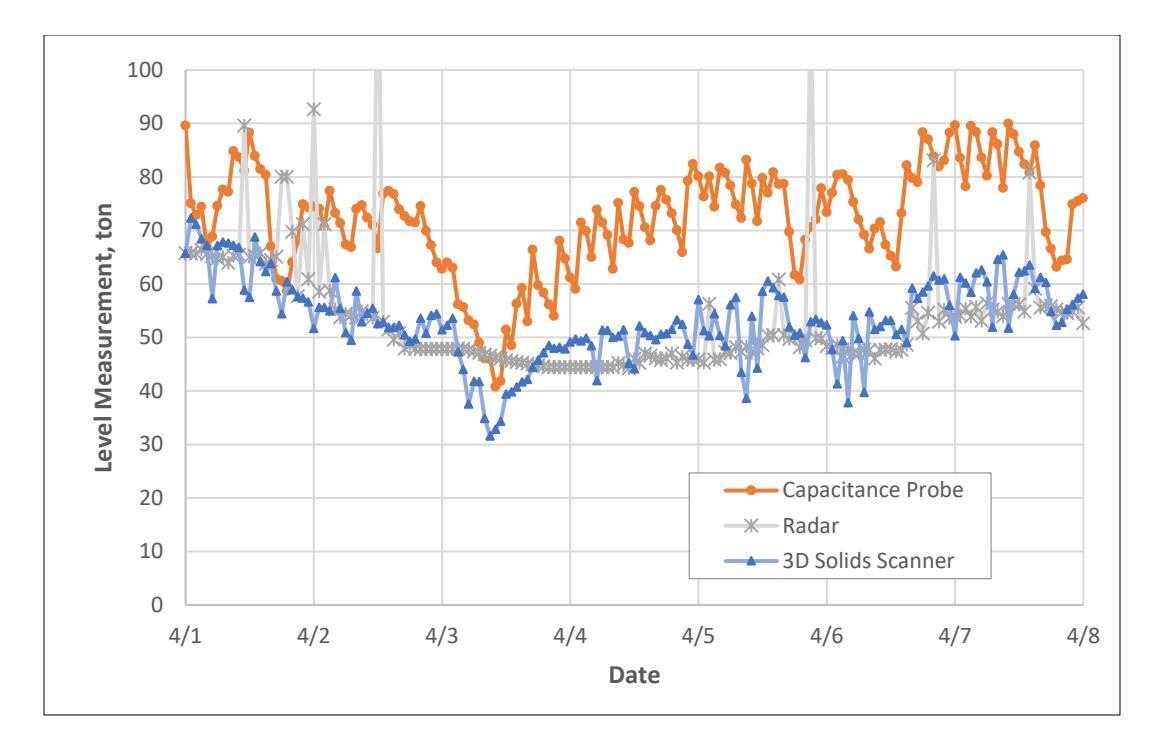
Figure 6 - Comparison of Coal Silo Level Measurements from the Three Devices

Figure 6 graphs the results from the run. The measurements showed similar trends but deviated in value. The level derived from the capacitance probe was typically 20 tons higher than that of the Solids Scanner. The radar measurement, while often giving bad data points, tracked more closely with the Solids Scanner. It should be noted that the capacitance probe and the radar instruments use calculations based on the measured height/level in the silo to determine a quantity of coal (in tons), while the Rosemount 5708 is a constant calculation; this difference could contribute to the offset changing as the level in the silo changed.

As an additional comparison, the Rosemount 5708 pulverized-coal silo fill-rate data was compared to the corresponding drop-rate of the Foster Wheeler crushed silo and the pulverized coal feed rate to the gasifier, and this gave some credibility to the measurement. It is also worth noting that the Rosemount 5708 did not see a level above 75 tons which is considerably less than the 120-ton vessel capacity. The capacitance probe instrument was prematurely stopping feed to the silos earlier than necessary, and more coal could have been added to the silos.

Therefore, although more testing is needed to verify the accuracy of the Solids Scanner, it appeared to be the most reliable level indicator of the three types, and the most suitable for use in automatic control of the silo. Based on the run data, controlling the silo level based on

the Solids Scanner instead of the capacitance probe would allow fuller utilization of the silo's capacity.
